**BAD090**  
White finish

**BAI090**  
White finish

### General description

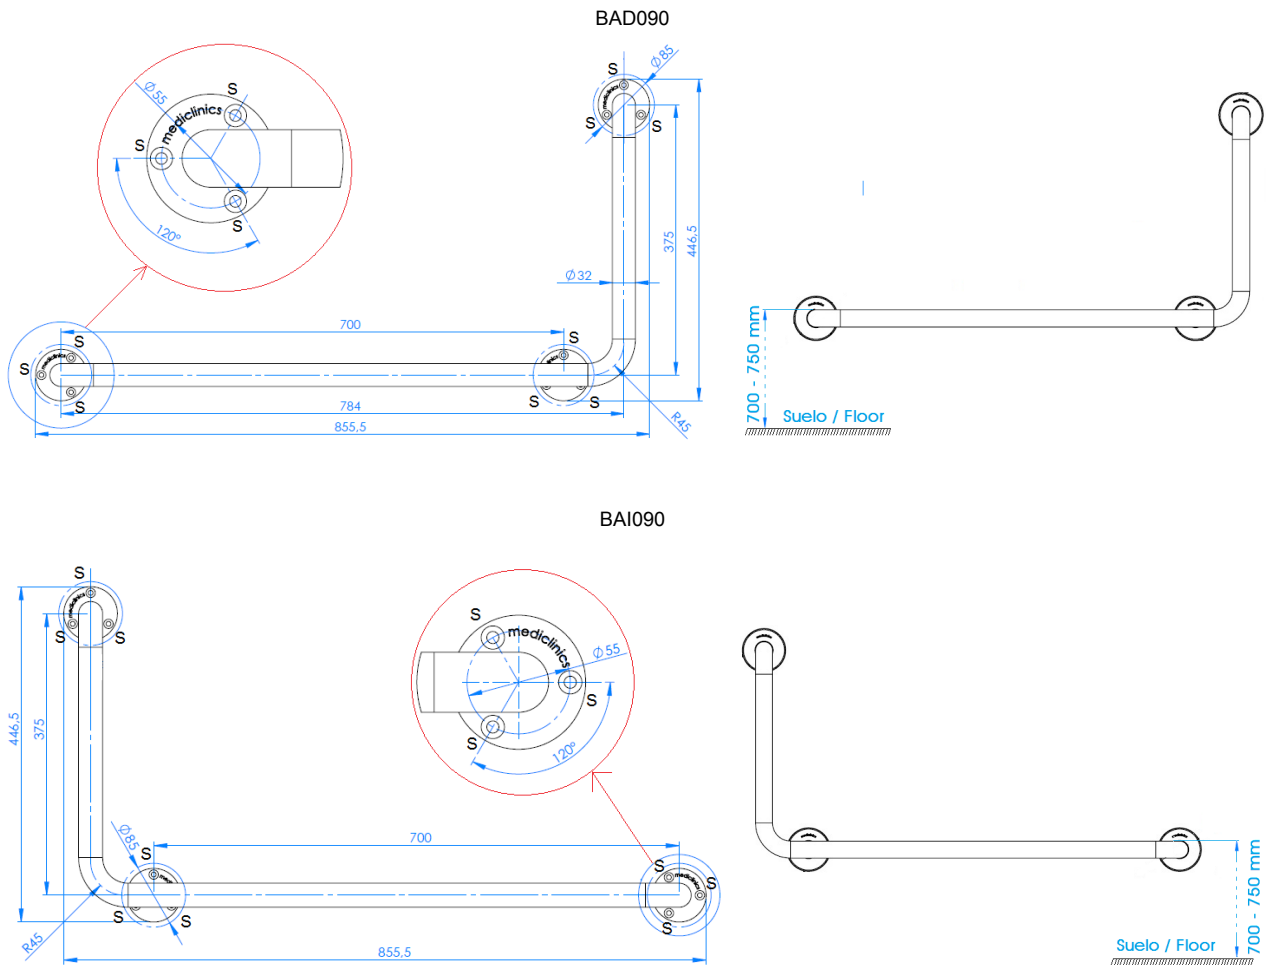
## MOUNTING TEMPLATE

Fix the grab bar to the wall through the 3 holes of each mounting flanges to the wall, using the screws provided and taking into account the distances of the points indicated by an "S" in the following figure:
